Q9.99_V1.1 known issues

for STM ATB V1.1

Colophon	
Document ID	Q9.99_V1.1
Version	4.0
Revision	792504
Author	JW
Reviewed	792504 ,STMA-83343
Approved	792504 ,STMA-83345
Archive	
Date:	2023/10/12 13:13

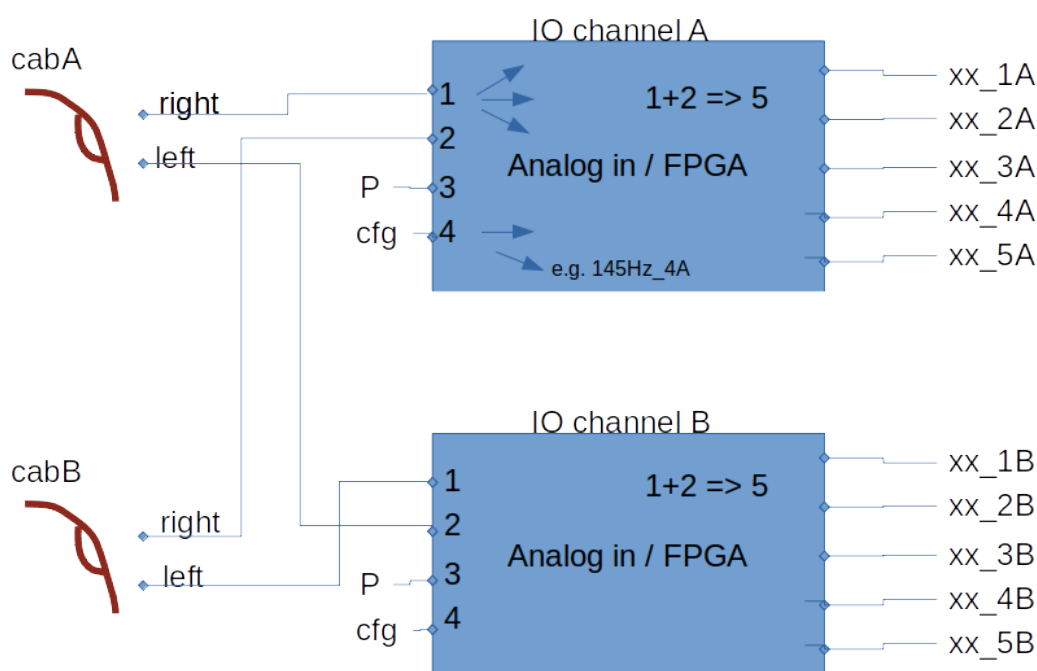
Definition, STMA-82856 -

STMA-82855 - Coil signals are related to a cabin, to an IO channel and to a number in the AD range. The differences in numbering should be clarified with an additional picture in D5.2.1.

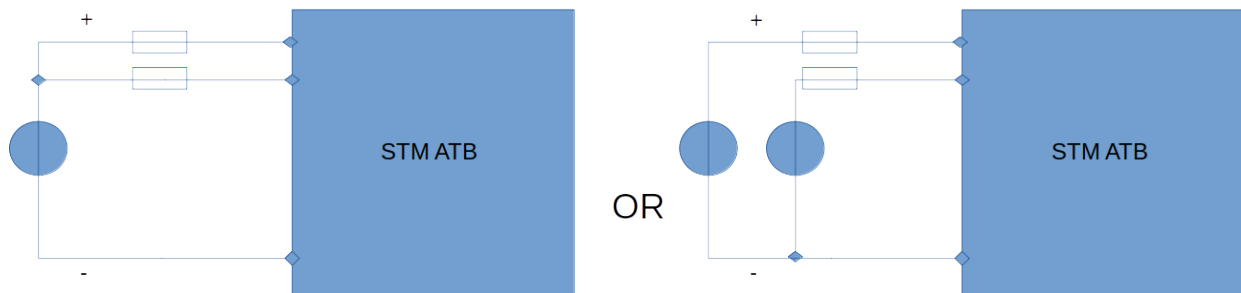
Definition, STMA-82859 - Power supply options

[STMA-68344](#) - The STM ATB shall be electrically connected to: * ETCS onboard sytem (Profibus i... i t is stated "...commonly supplied via one multi signal circuit breaker". During installation projects it appeared this formulation is unclear. The intention is that both power connections shall be supplied from a voltage source with a common minus, and separately protected plus lines. See figure below, where the indicated fuses may any kind of protection, fit for the STM ATB supply voltage and current.
